Uptime Institute®

От проектирования к эксплуатации ЦОД: типичные ошибки

ЧАСТЬ 1. НАДЕЖНОСТЬ ИНФРАСТРУКТУРЫ, ИЛИ О ПРОЕКТИРОВАНИИ КАК ТАКОВОМ

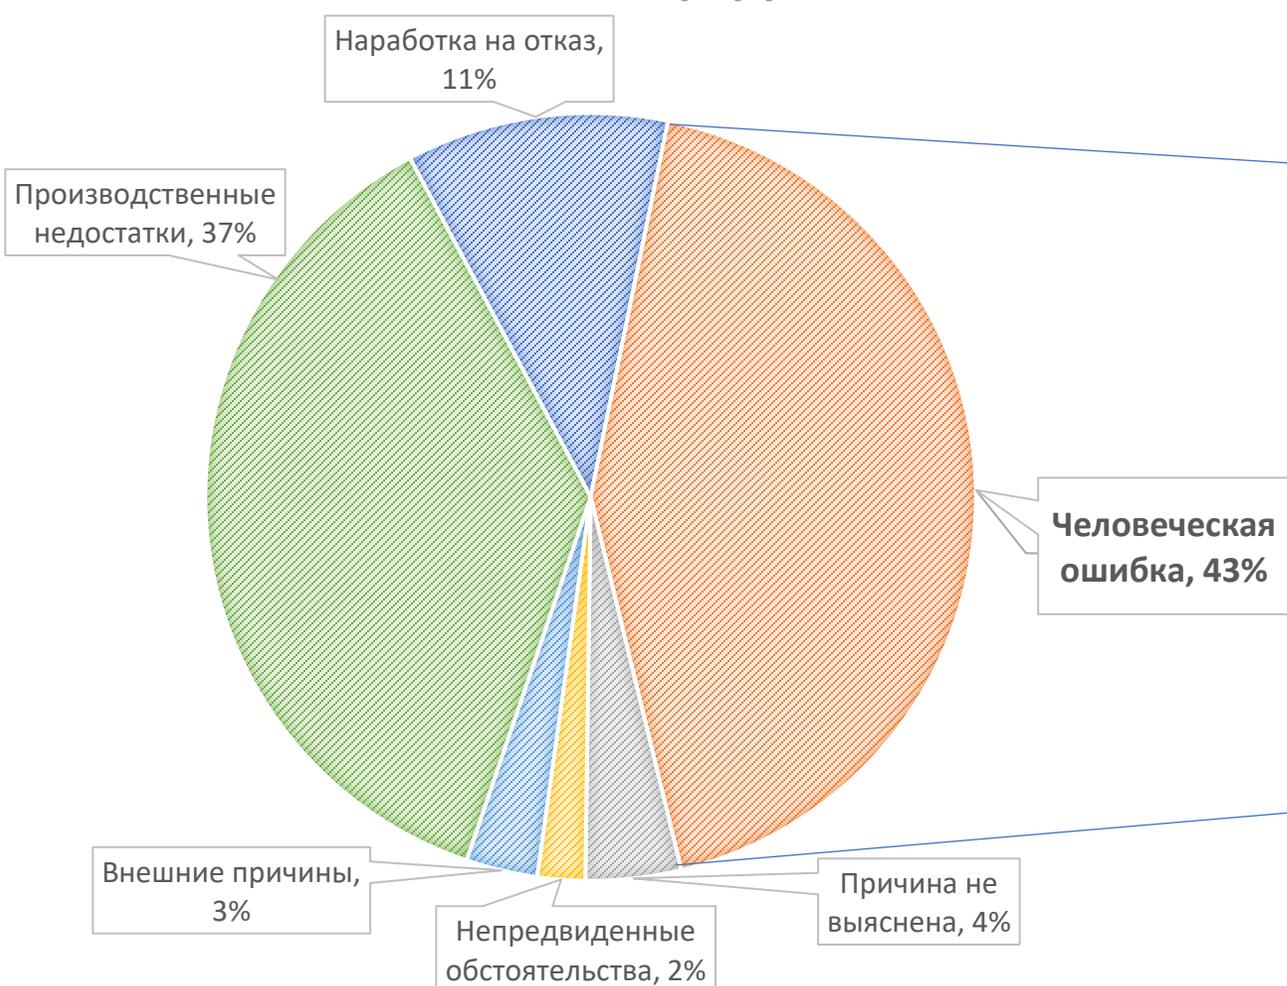
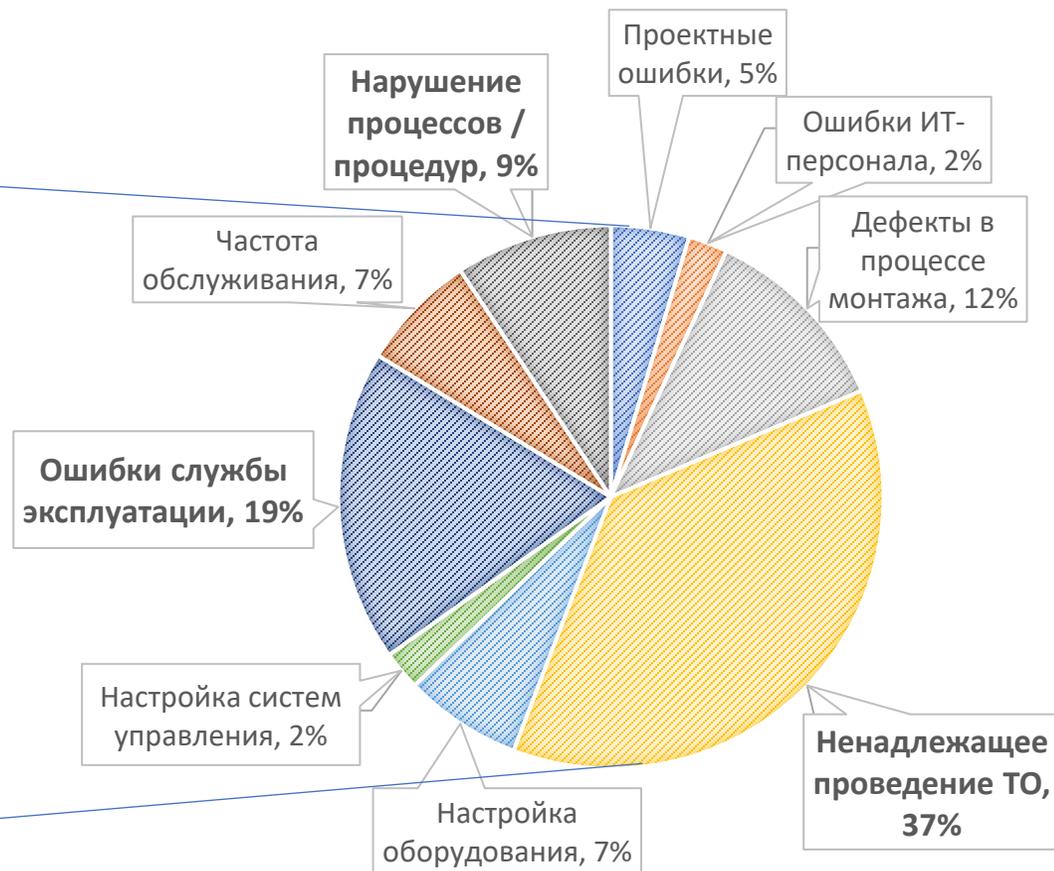
Статистика всех инцидентов

ТИПЫ ЧЕЛОВЕЧЕСКОЙ ОШИБКИ

ПРИЧИНЫ ИНЦИДЕНТОВ

81% инцидентов по вине человека происходят в ходе повседневной эксплуатации ЦОД

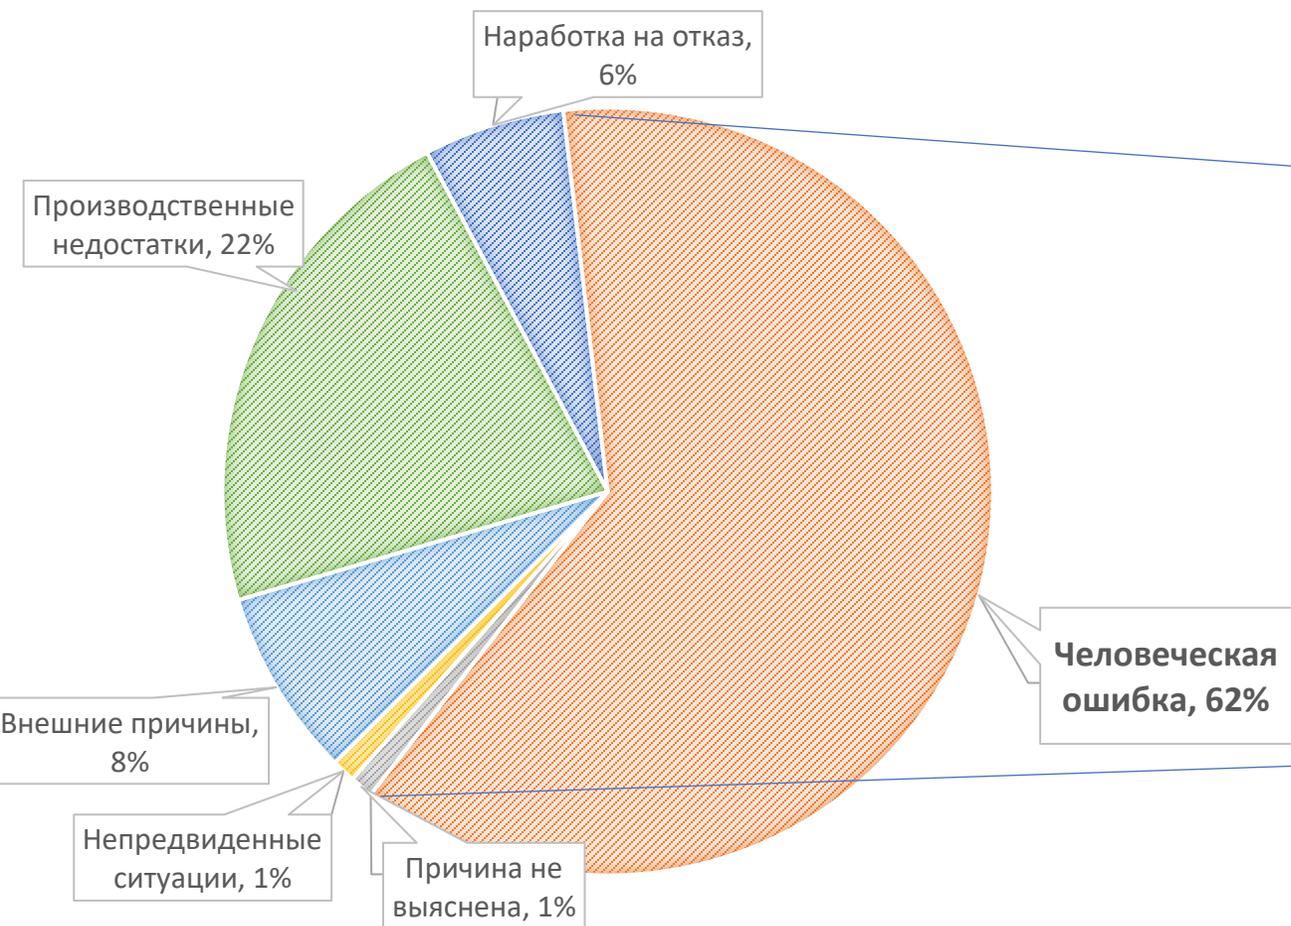
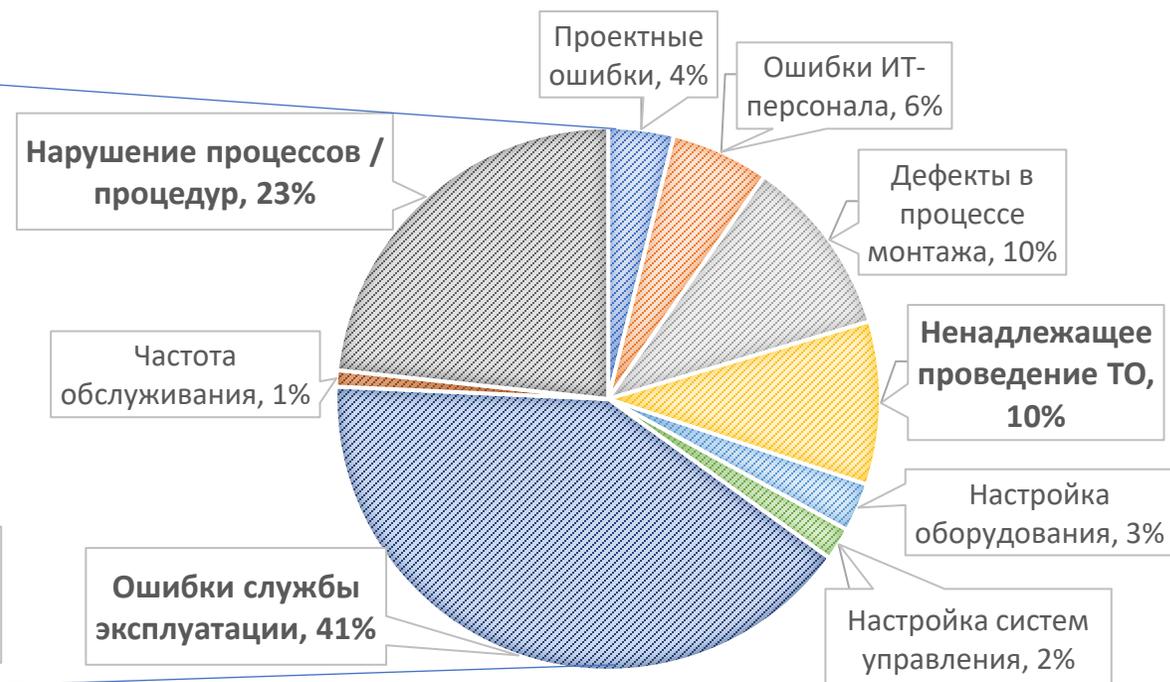
Статистика аварий, вызвавших отключение нагрузки

ПРИЧИНЫ АВАРИЙ

ТИПЫ ЧЕЛОВЕЧЕСКОЙ ОШИБКИ

80% аварий по вине человека происходят в ходе повседневной эксплуатации ЦОД

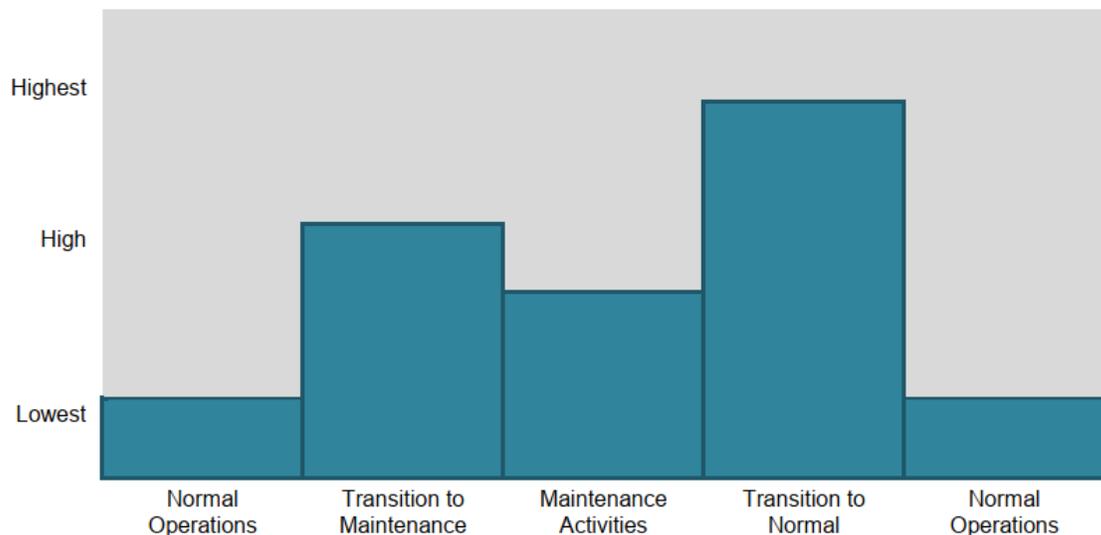
Figure 8-1
Risk During Normal vs Maintenance Modes

Изображение из стандарта BICSI 009-2019 "Data Center Operations and Maintenance Best Practices"
